**DEPARTMENT OF TRANSPORTATION****DIVISION OF ENGINEERING SERVICES**

Contract #: 04-0120F4Cty: SF/ALA Rte: 80 PM: 13.2/13.9File #: 1.28**WELDING INSPECTION REPORT****Resident Engineer:**Siegenthaler, Peter**Address:** 333 Burma Road**City:** Oakland, CA 94607**Report No:** WIR-025409**Date Inspected:** 03-Aug-2011**Project Name:** SAS Superstructure**OSM Arrival Time:** 700**Prime Contractor:** American Bridge/Fluor Enterprises, a JV**OSM Departure Time:** 1530**Contractor:** American Bridge/Fluor Enterprises, a JV**Location:** Jobsite

**Bridge No:** 34-0006**Summary of Items Observed:**

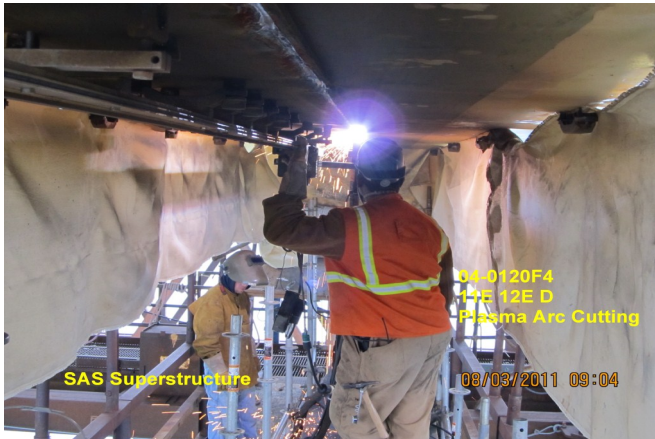
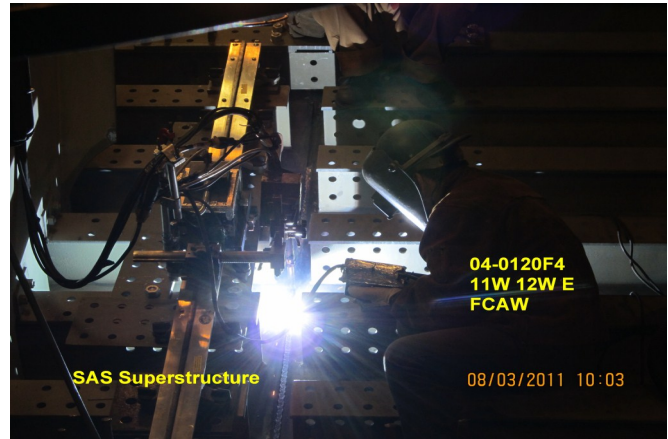
The QA inspector randomly observed ABF welder Fred Kaddu ID#2188 utilizing the Plasma Arc Cutting (PAC) method to remove the backing bar from the exterior face of bottom plate D at 11E 12E. The work progressed throughout the shift and the QA inspector noted that the work appeared to be in general conformance with the contract documents.

The QA Inspector randomly observed ABF welding operator Hua Qiang Hwang ID#2930 performing Flux Core Arc Welding w/gas (FCAW-G) operations in the 3G vertical position on side plate E located at 11E 12E on the interior of the OBG. The QA Inspector observed the QC Inspector Tony Sherwood as being present in order to

The QA Inspector randomly observed ABF welding operator James Zhen ID#6001 performing Flux Core Arc Welding w/gas (FCAW-G) operations in the 4G overhead position on bottom plate D located at 10W 11W on the exterior of the OBG. The QA Inspector observed the QC Inspector Pat Swain as being present in order to monitor the progress and ensure the welding parameters were in compliance pertaining to ABF-WPS-D15-3042B-1. The work was completed on this date and the QA Inspector noted that the work appears to be in general conformance with the contract documents.
